L2S from Zentrix

Problem found of 1 out of 8

Hybrid #4

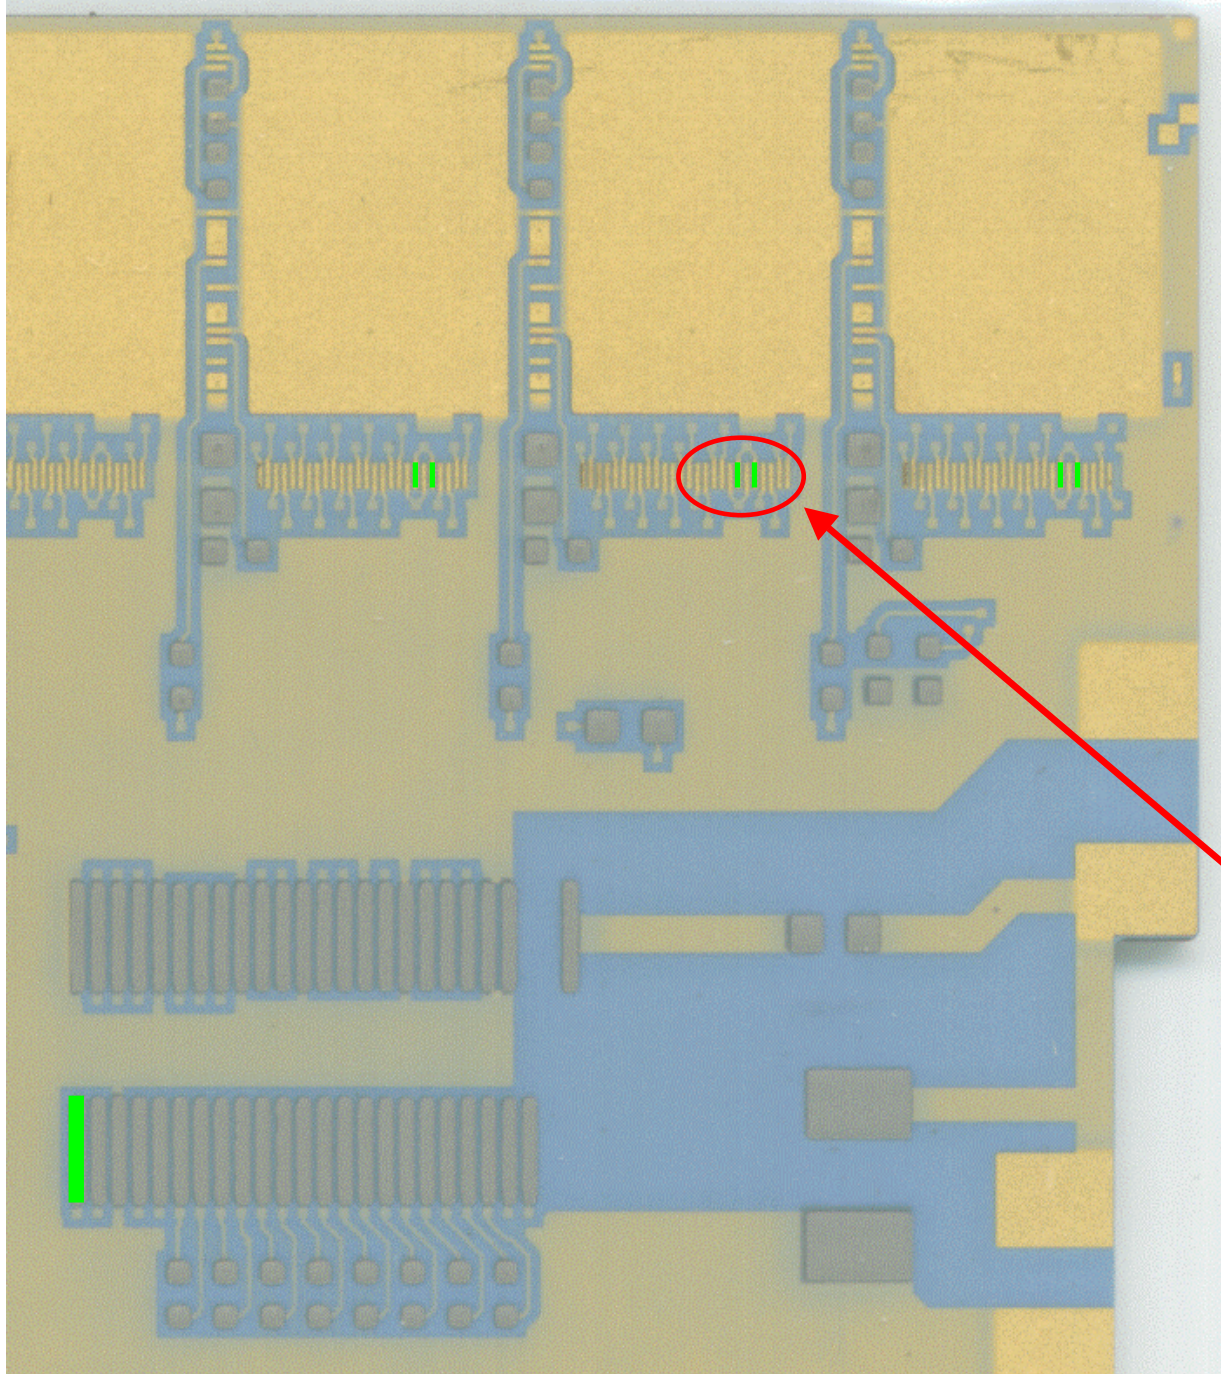
Clk pad is open as indicated
on diagram (all green pads are
supposed to be connected)

Open pads (Clk)
